# HELP RESTORE THE TOWER

We have exciting plans for the refurbishment of the Saxon Tower and how we display the church's historic artefacts. You can see some of our ideas on the other side of this leaflet.

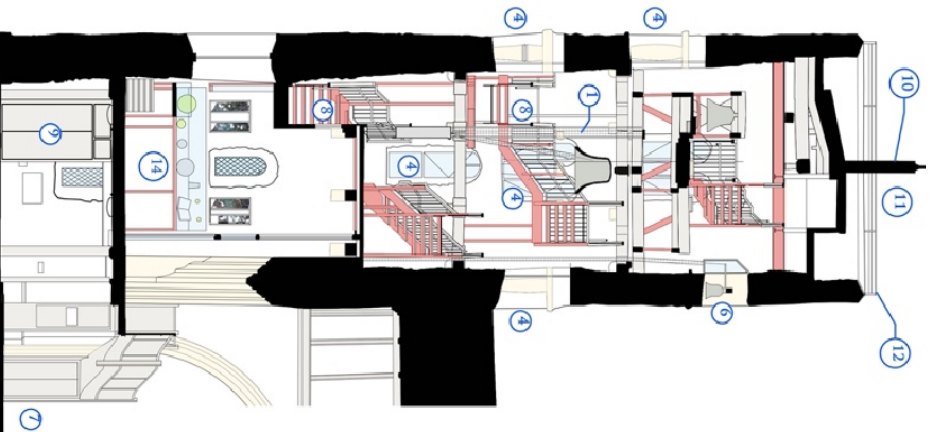
SECTION B - SHOWING PROPOSALS

1. Bell ropes to Ellacombe chimers and sanctus bell replaced and contained within a stainless steel mesh enclosure.
2. Clock mechanism replaced with a modern winding version.

3. Enclosure to Ellacombe mechanism; replace panels to door with safety glass.
4. Improve pigeon control measure to windows and replace modern windows to allow easier maintenance and improve visibility; new windows to be steel or bronze slim casements carefully installed to expose the stonework internally and externally.

5. Oak and glass display cabinet for clock mechanism.
6. Opening for Sanctus bell improved with new window to be installed to allow maintenance.
7. Reconsider the layout and integration of the tower visitor route with the remainder of the church.

8. Redecorate staircase, reshape the handrails to be more ergonomic, add a secondary lower handrail for children, replace tread and platform with oak boards, install solid oak risers at low level to prevent accumulation of dust above fire rated ceiling.

9. Rectify base of tower room.
10. Re-gild & decorate weather vane.
11. Renew leadwork, incorporate rooflight into roof of stair.
12. Replace parapet handrails, incorporating new skyline boards and making them higher for safety reasons.

13. Test boxing to seebs for asbestos and remove; paint beams with intumescent paint.
14. Treasury room improved with new display cabinets.
15. Walls to stairs removed and replaced a glazed oak, fire rated wall.
